THE LEUCHTER REPORTS

CRITICAL EDITION

Fred A. Leuchter, Jr., Robert Faurisson, Germar Rudolf *The Leuchter Reports. Critical Edition* 5th, corrected and enhanced edition

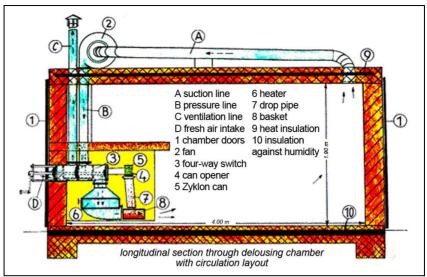
Fig. 4: DEGESCH delousing chamber with circulation feature. ⁵² This design was developed in the late 1930s / early 1940s and became a standard in Germany during the war. It was, however, not installed in all concentration camps, which were frequently equipped with makeshift delousing chambers. Editor's note.

The procedure can be vastly accelerated when using special fumigation chambers designed like the DEGESCH "Kreislaufanlage" (circulation facility), see Gerhard Peters, E. Wüstinger, "Entlausung mit Zyklon-Blausäure in Kreislauf-Begasungskammern. Sach-Entlausung in Blausäure-Kammern," Zeitschrift für hygienische Zoologie und Schädlingsbekämpfung, 32 (10/11) (1940), pp. 191-196; cf. also F.P. Berg,"The German Delousing Chambers," Journal of Historical Review, 7(1) (1986), pp. 73-94.

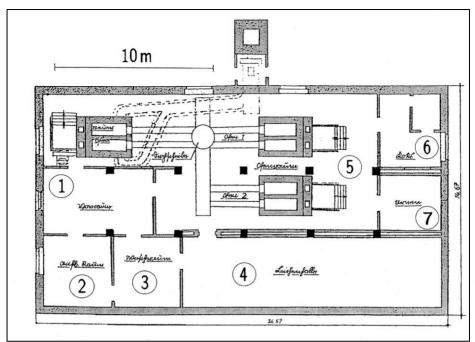
Fig. 5: Ground plan of Crematorium I in Auschwitz I/Main Camp in its original condition. The morgue was later allegedly used as a homicidal gas chamber. 1: vestibule; 2: laying-out room; 3: wash room; 4: morgue; 5: furnace room; 6: coke; 7: urns

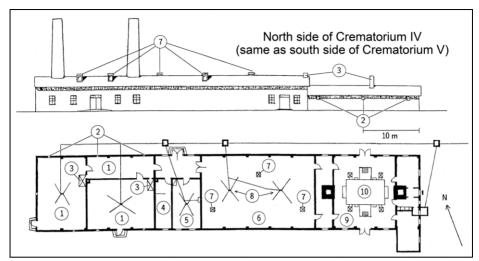
Fig. 8: North elevation (above) and ground plan (below) of crematorium IV and/or V (mirror image) in Auschwitz II/Birkenau camp. 159

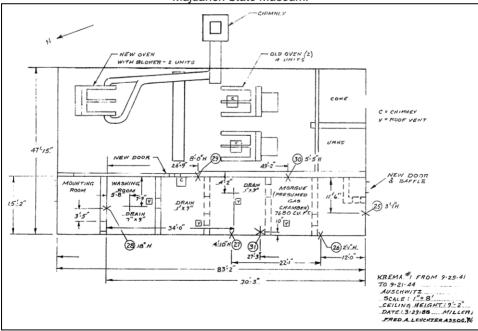
Fig. 13: Floor plan of Krematorium I in Auschwitz main camp, drawn by H. Miller, Fred A. Leuchter Associates. Numbers in circles denote locations where wall sample were taken.

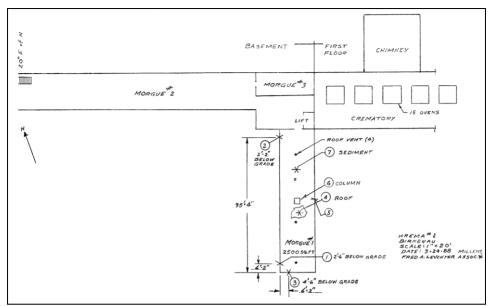
Fig. 14: Floor plan of Krematorium II in Auschwitz Birkenau, drawn by H. Miller, Fred A. Leuchter Associates. Numbers in circles denote locations where wall sample were taken. Note: The "Roof Vent (4)" do not exist; see document on next page.

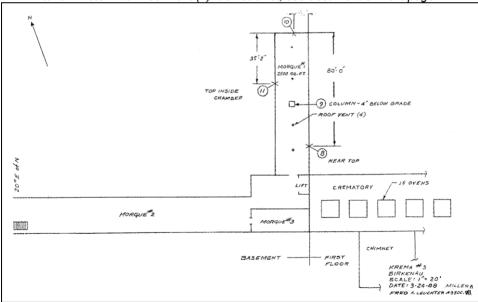
Fig. 15: Floor plan of Krematorium III in Auschwitz Birkenau, drawn by H. Miller, Fred A. Leuchter Associates. Numbers in circles denote locations where wall sample were taken. Note: The "Roof Vent (4)" do not exist; see document on next page.

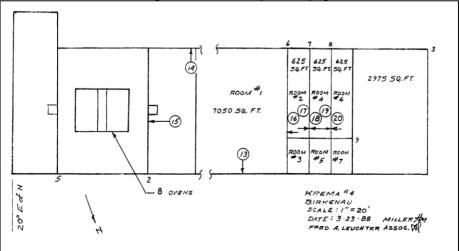
Fig. 17: Floor plan of Krematorium IV in Auschwitz Birkenau, drawn by H. Miller, Fred A. Leuchter Associates. Numbers in circles denote locations where wall sample were taken.

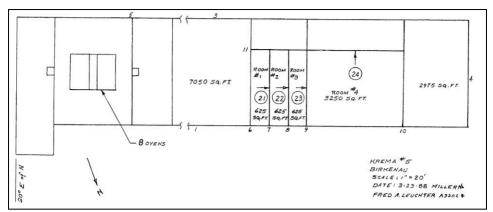
Fig. 18: Floor plan of Krematorium V in Auschwitz Birkenau, drawn by H. Miller, Fred A. Leuchter Associates. Numbers in circles denote locations where wall sample were taken.

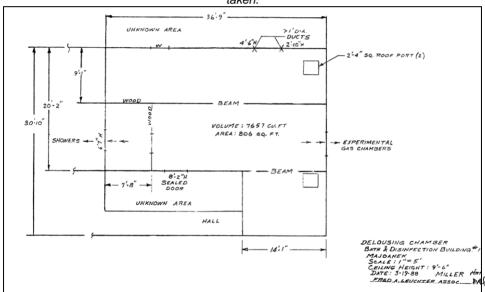
Fig. 19: Floor plan of Bath & Disinfection Building #1 at the Majdanek camp, drawn by H. Miller, Fred A. Leuchter Associates.

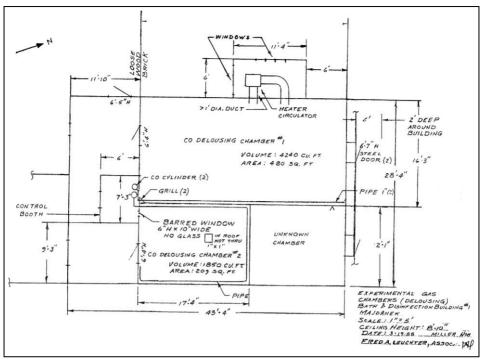
Fig. 20: Floor plan of the delousing wing of Bath & Disinfection Building #1 at the Majdanek camp, drawn by H. Miller, Fred A. Leuchter Associates.

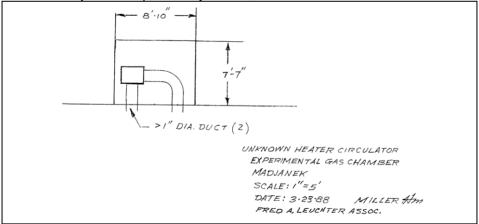
Fig. 21: Sketch of Heater Circulator of delousing chamber in previous document, drawn by H. Miller, Fred A. Leuchter Associates.

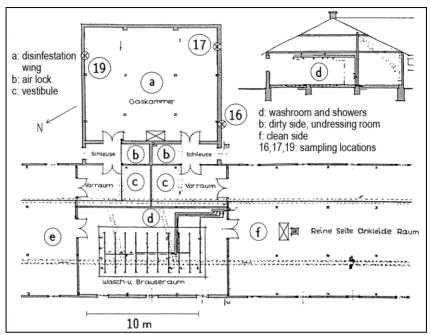
Fig. 24: Ground plan of the HCN disinfestation wing of Building 5a before building alterations (mirror image) and BW 5b today. BW 5b sample-taking locations for the Rudolf Report drawn in. 194

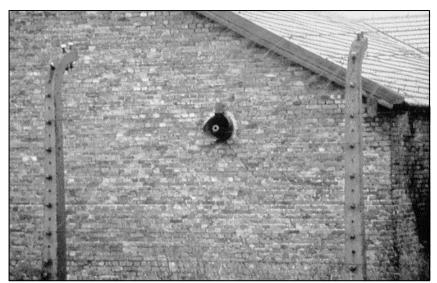
Fig. 25: One of the two ventilation outlets from the disinfestation wing of Building BW 5b, without equipment today. The other is located on the same wall slightly to the left. The end of a water pipe installed after the war is protruding out of the hole.

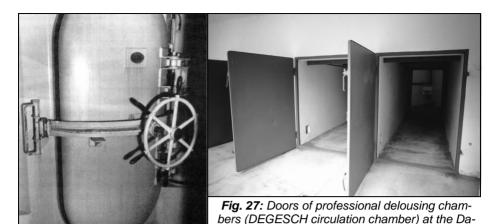
Fig. 28: Door of the execution gas chamber for a single person in Baltimore, USA, 1954, Technology from the 1930s.

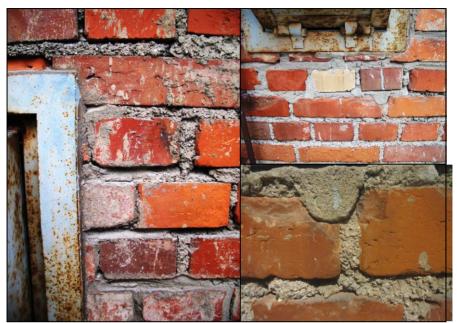
Fig. 50a (left), b, c (right): external view of the alleged "Zyklon B introduction chutes" of the alleged gas chamber at Dachau. The different mortar used for the surrounding bricks proves that these holes were opened only after the wall had already been erected.

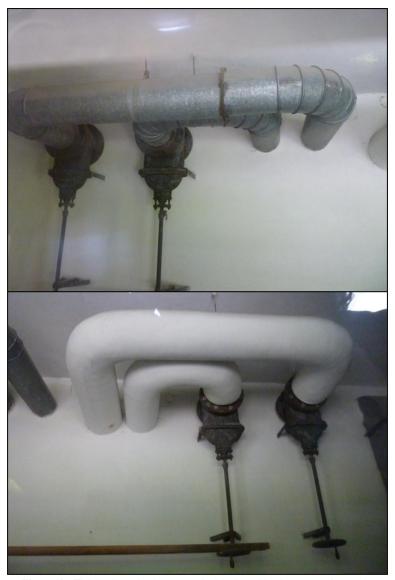
Fig. 54f.: Thick pipes in the room behind and in the area above the Dachau "gas chamber."

The air left the gas chamber through two grilled openings in the ceiling, entering into two pipes of 200mm diameter each. These two pipes were led into the adjoining room as well and could there

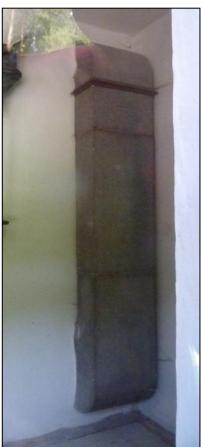
Fig. 57: Warm-air-supply shaft behind the Dachau gas chamber.

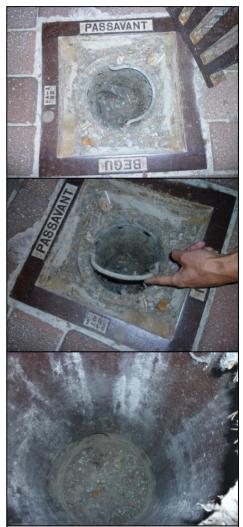
Fig. 61a & b: One of the six floor drains inside the alleged gas chamber at Dachau. Left: grate removed, sieve in place; right: sieve removed; the exit drain pipe can be seen at the drain's bottom (topmost spot of the bottom).

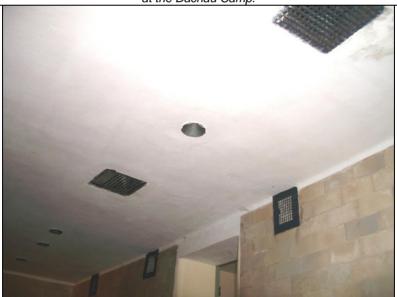
Fig. 65: Ceiling of the alleged gas chamber at the Dachau Camp; circular: four false shower heads; square-shaped with grates: the two air extraction holes. At the wall: three lamp recesses with grates.

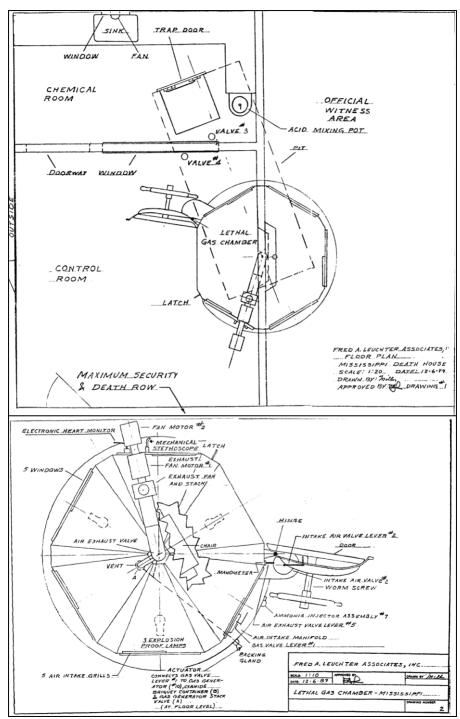
Fig 83 & 84: Technical drawings of the Parchman (Miss.) execution gas chamber.

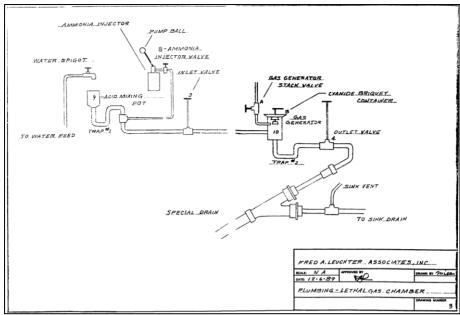
Fig 85: Technical drawing of gas generator of the Parchman (Miss.) execution gas chamber.

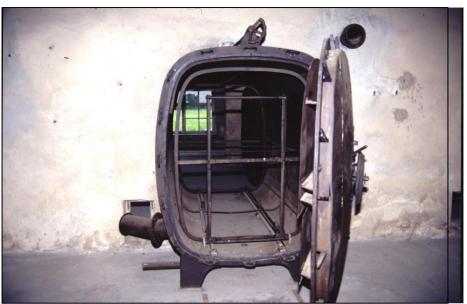
Fig. 92: Hot-air-disinfestation autoclave in the so-called "Zentralsauna" in Auschwitz-Birkenau with similar doors as used for the U.S. execution gas chambers. Although the German camp authorities had the technology required for constructing execution gas chambers, they did not use it. They used this technology to save the lives of their prisoners instead.

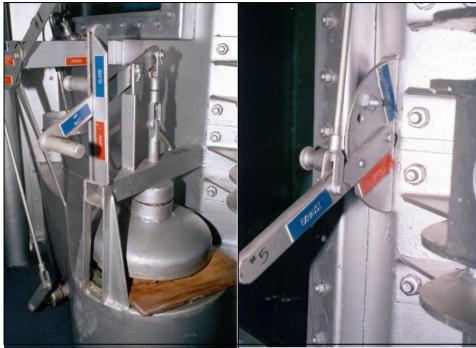
Fig. 98: Closeup of fresh-air intake of gas chamber.

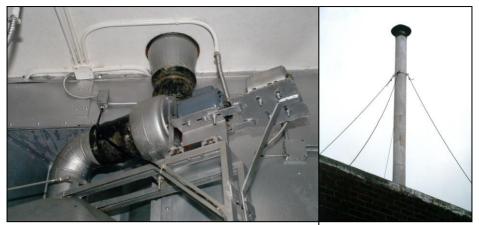
Fig. 102: Exhaust fan and stack on top of gas chamber. Fig. 103: Exhaust stack.

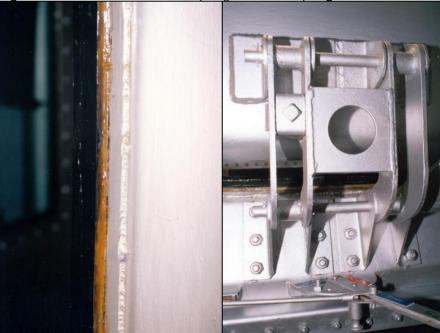
Fig. 104: Closeup of rubber seal around gas chamber door, also covered in Vaseline when in use.

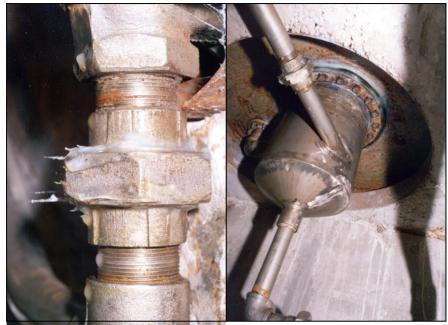
Fig. 106: Closeup of plumbing underneath the gas chamber covered in Vaseline to indicate leaks.

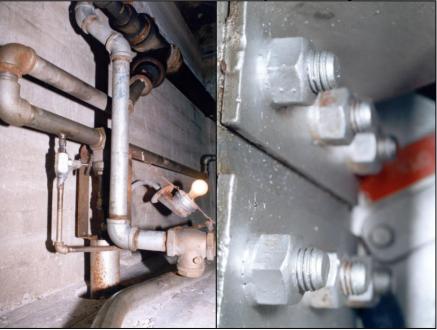
Fig. 108: Portion of plumbing and sewage system connecting chemical room to gas chamber.

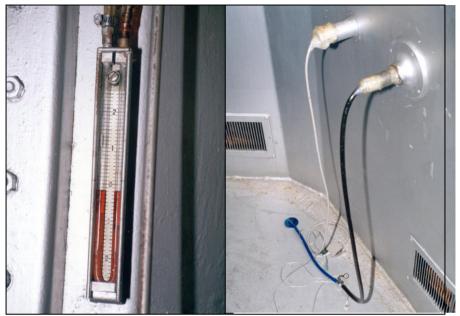
Fig. 110: Manometer to monitor relative gas chamber pressure.
